881 Fletcher Valley Crescent, Mississauga, ON July 29, 2021

Report No. 8392

SUMMARY

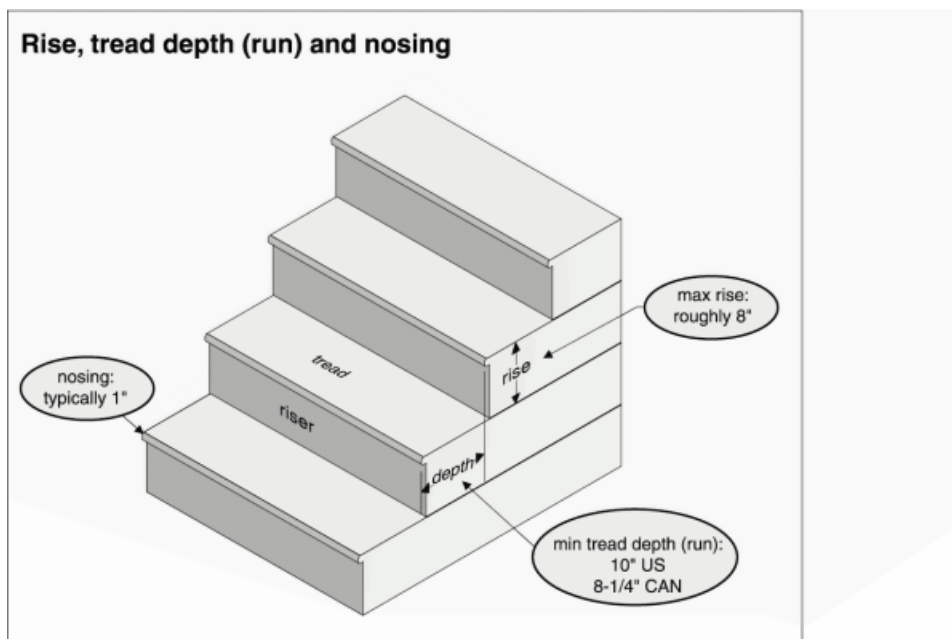
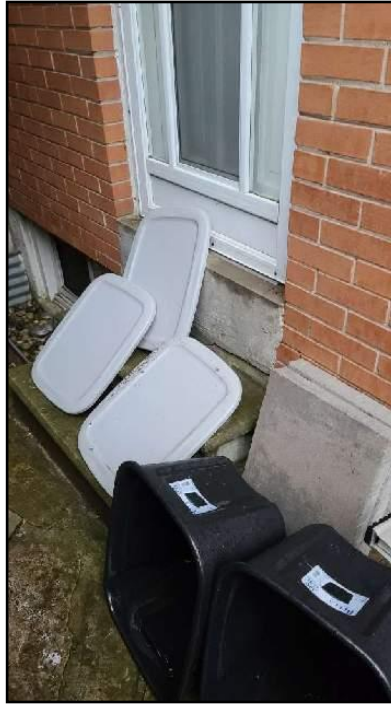
1.

Condition: • [Stair rise too big or not uniform](#)

Implication(s): Trip or fall hazard

Location: Exterior

Task: Improve

Time: Immediate

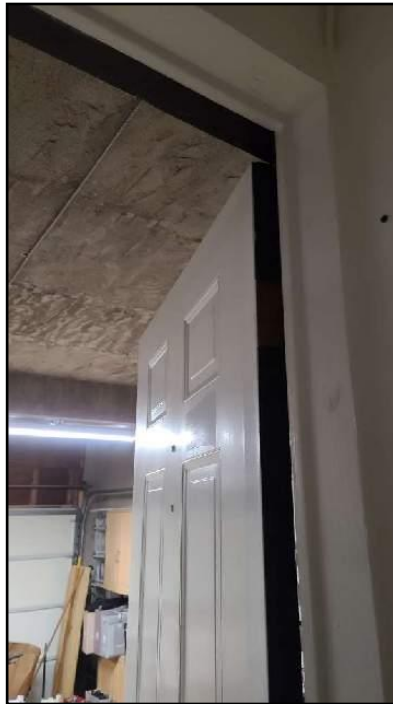
2.

Condition: • [No self-closer](#)

Implication(s): Hazardous combustion products entering home | Increased fire hazard

Location: First Floor Garage

Task: Provide

Time: Immediate

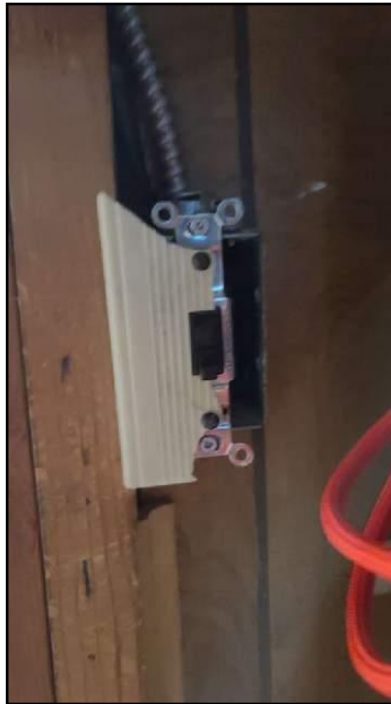
3.

Condition: • [Damaged](#)

Implication(s): Electric shock

Location: Basement Furnace Room

Task: Replace

Time: Immediate

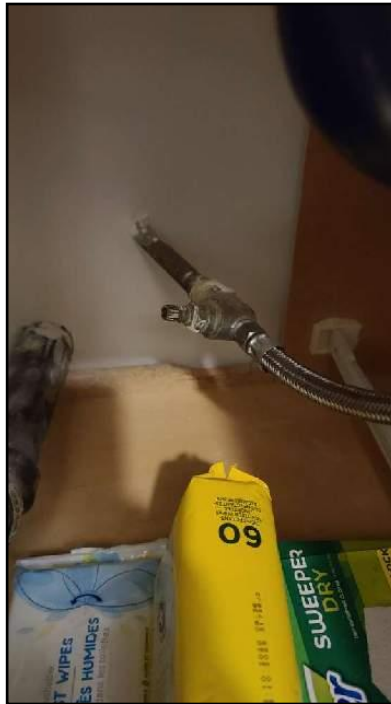
4.

Condition: • [Damaged handle](#)

Implication(s): Physical injury | Difficult to service

Location: Basement Bathroom

Task: Provide

Time: Regular maintenance

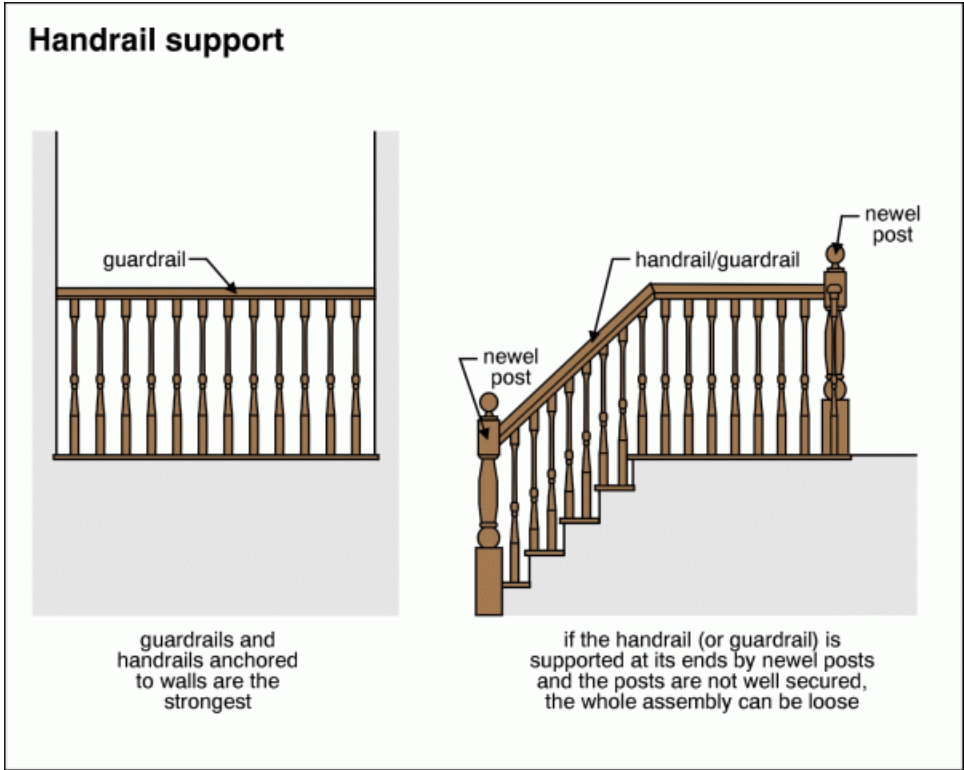
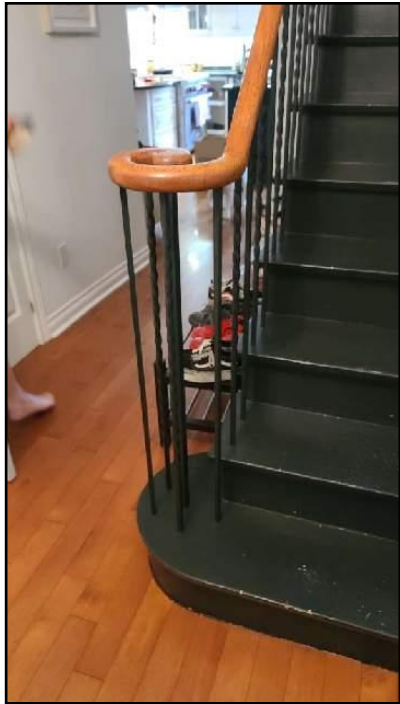
5.

Condition: • [Loose](#)

Implication(s): Fall hazard

Location: First Floor

Task: Improve
Time: Regular maintenance

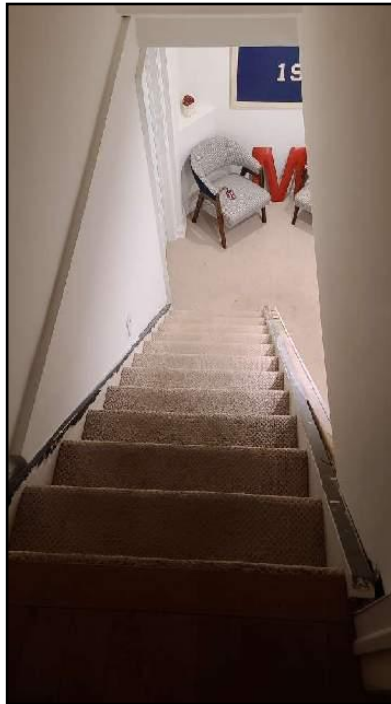
6.

Condition: • [Missing](#)
Implication(s): Fall hazard
Location: Basement Staircase
Task: Provide
Time: Immediate

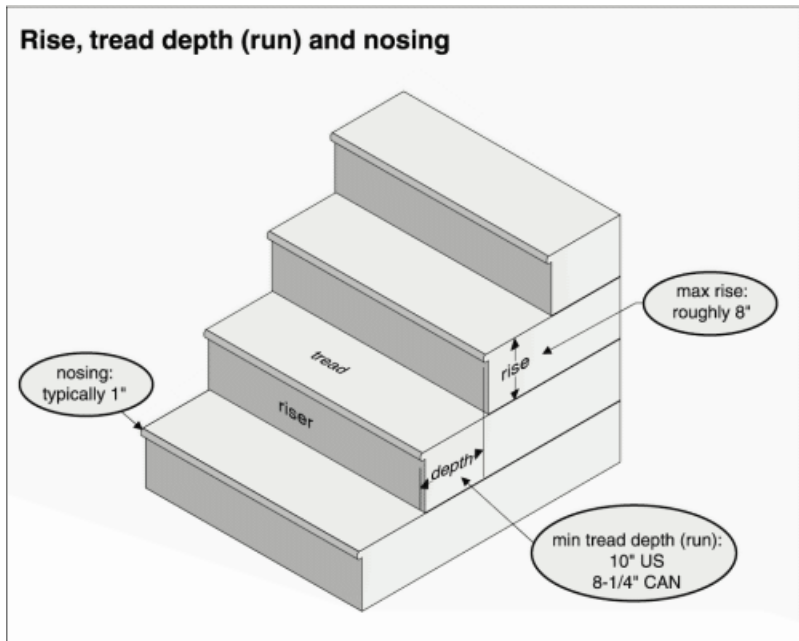
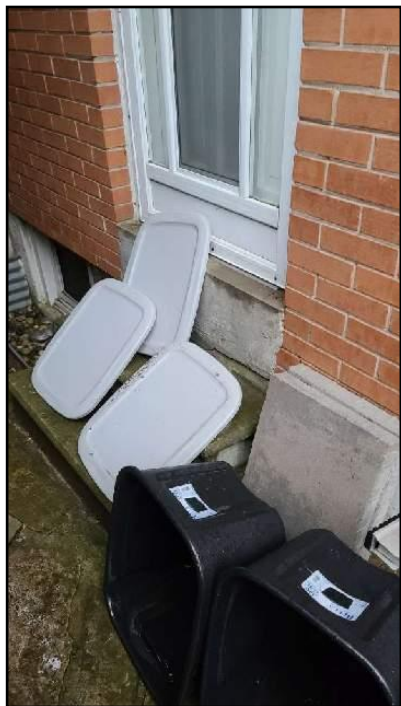
20.

Condition: • [Stair rise too big or not uniform](#)

Implication(s): Trip or fall hazard

Location: Exterior

Task: Improve

Time: Immediate

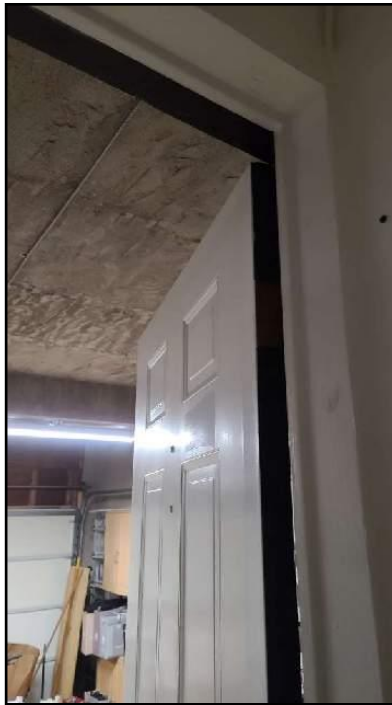
21.

Condition: • [No self-closer](#)

Implication(s): Hazardous combustion products entering home | Increased fire hazard

Location: First Floor Garage

Task: Provide

Time: Immediate

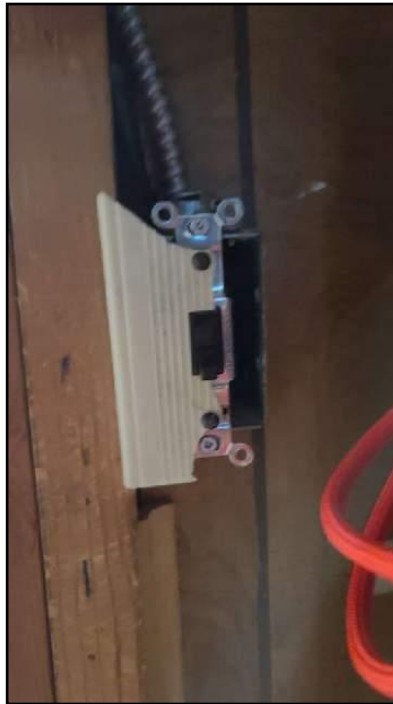
36.

Condition: • [Damaged](#)

Task: Replace

Time: Immediate

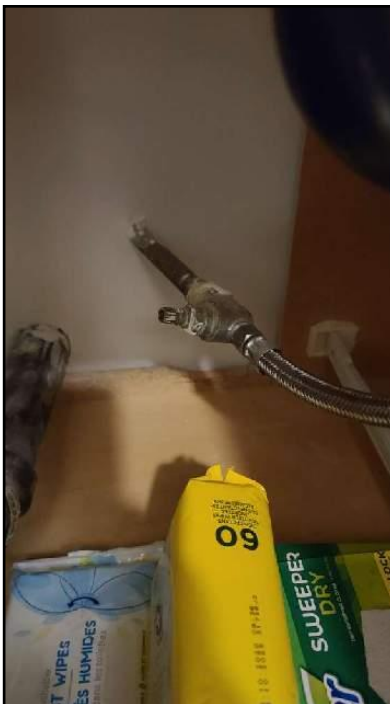
53.

Condition: • [Damaged handle](#)

Task: Provide

Time: Regular maintenance

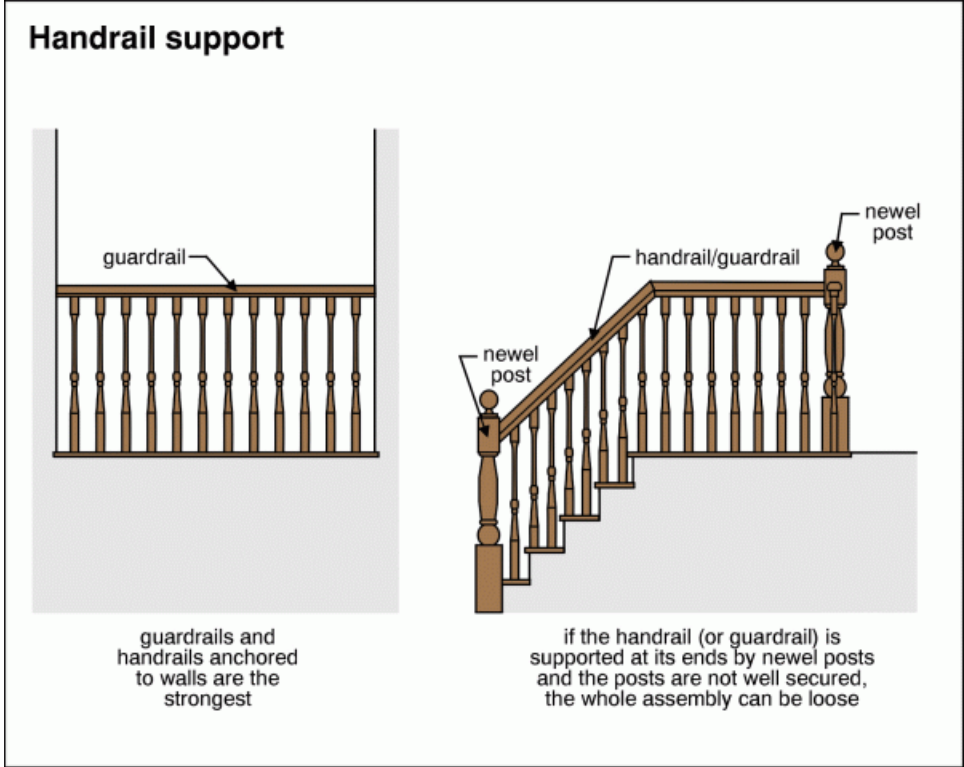
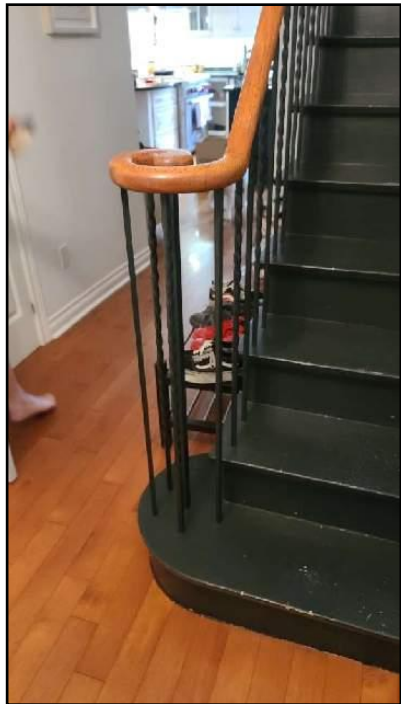
54.

Condition: • [Loose](#)

Implication(s): Fall hazard

Location: First Floor
Task: Improve
Time: Regular maintenance

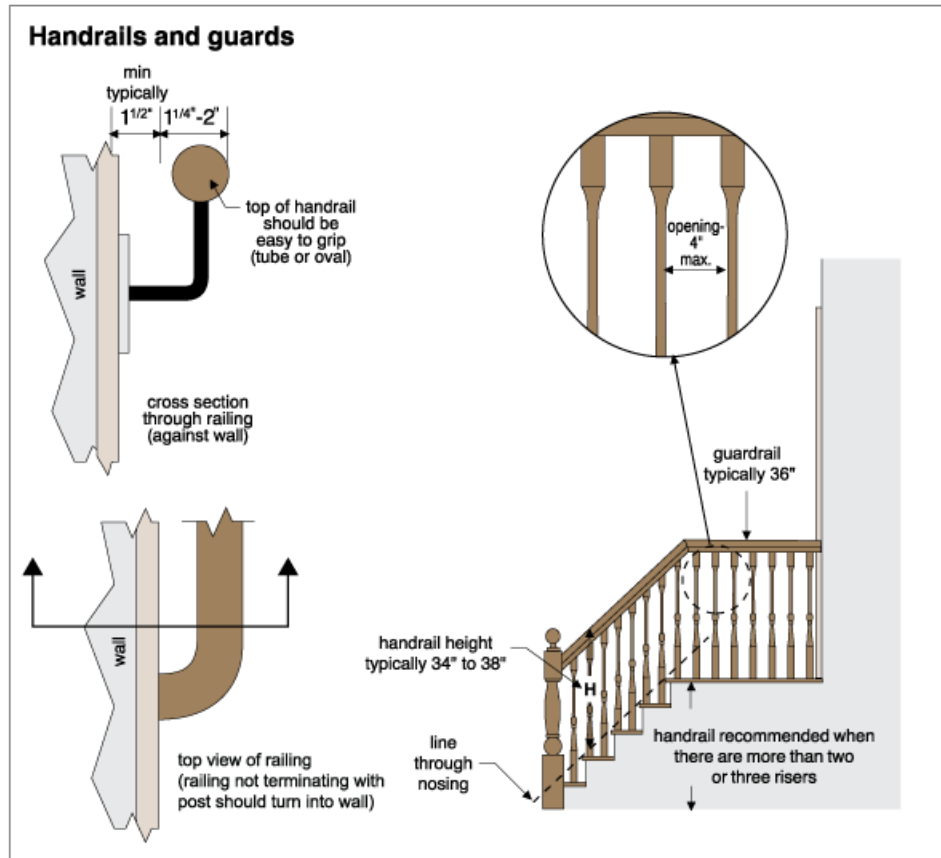
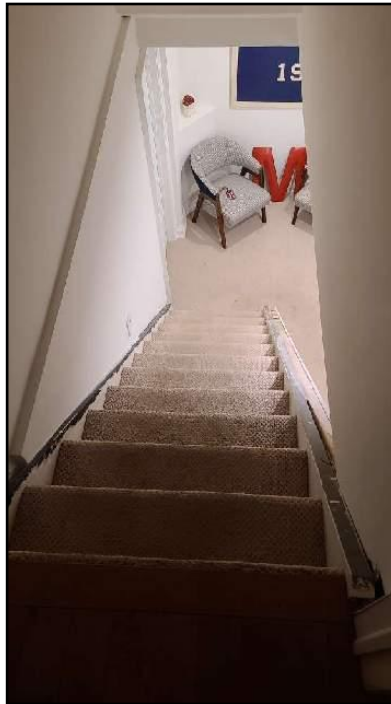
55.

Condition: • [Missing](#)
Implication(s): Fall hazard
Location: Basement Staircase
Task: Provide
Time: Immediate
