Building Inspection Report

1060 Walden Circle #53, Mississauga.

File #: 22220520.

Work Request: Pre-List Inspection.

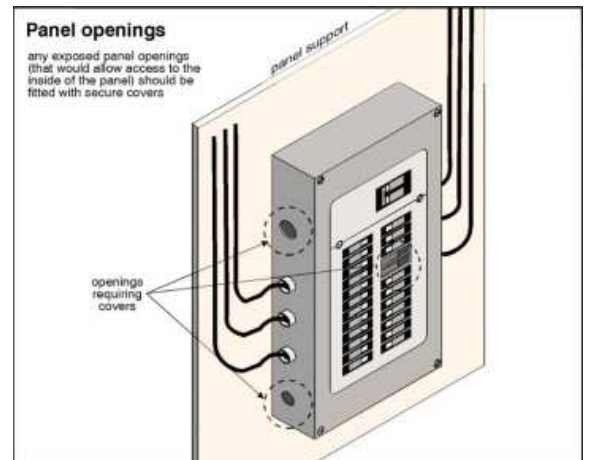
Unused openings in the main power disconnect panel are missing covers. Install the knock out covers to protect the openings.

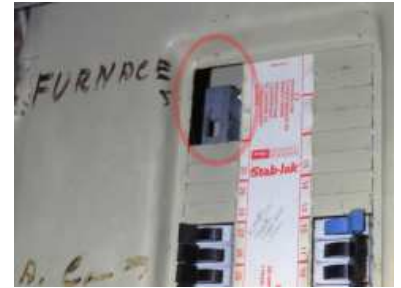
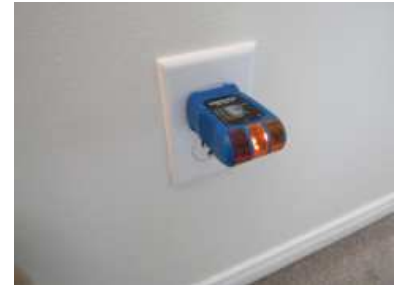
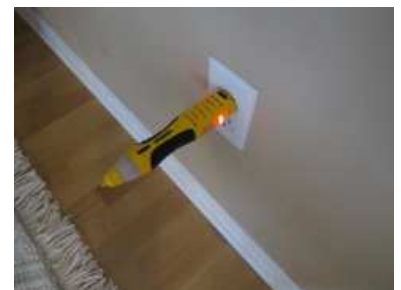
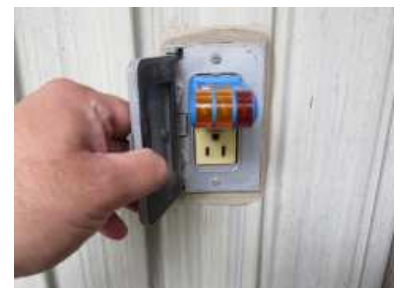
Receptacle electrical test failed indicating an incomplete or missing ground (*bare*) wire connection. This was typical for the age of the property. Repairs are discretionary.

Second tester used to verify the receptacles were ungrounded.

Electrical receptacle did not appear to have power. Rear exterior receptacle. Recommend repairs.

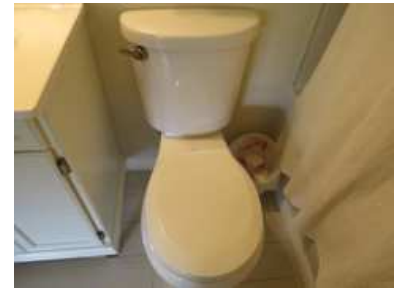
Toilet is loose. This condition could eventually result in water damage. No evidence of such at the time of the inspection. Recommend securing the toilets to the floor. Ensuite toilet.

- Secure toilets

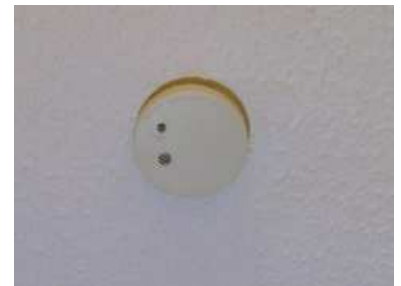
Smoke alarm older than 5 years may be beyond its life expectancy for safe operation. Replace with new CSA or ULC approved units. Main floor and lower level.
